1.0 Executive Summary

Following a major storm event on July 28, 2015 in which the City of Humboldt saw 122mm of rain within a 24 hours period, Catterall & Wright was asked to provide design services for drainage improvements for several locations in Humboldt, SK. One of these locations was Centennial Park, a multi-use park space that includes a high school, hockey arena, swimming pool, curling rink, 5 baseball diamonds and a skateboard park. Several of the on-site amenities were highly saturated after the storm event and many were submerged in water. The saturated land made it extremely difficult to survey the area using conventional methods further increasing the difficulty in capturing the extent of the drainage issues on the property. Due to the complex nature of the terrain and site features, it was decided that the park would be measured using a photogrammetry based multi-rotor UAV.

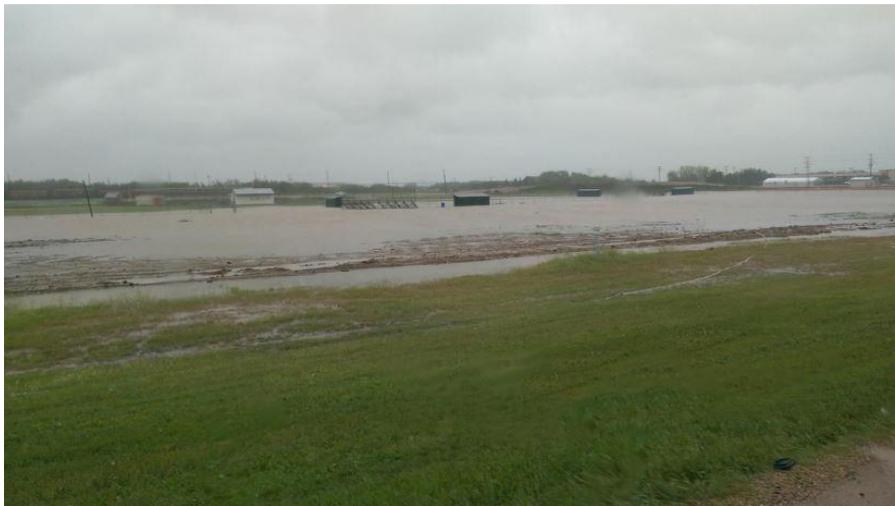
Figure 1: Looking south-west from Highway 5, showing the extent of drainage issues in Centennial Park following the 2015 storm event.
